Manhole Inspection Summary

Manhole # S47GG_048MH

Insp Date: **6/17/08 11:17 AM**

Location Address: **Preston**

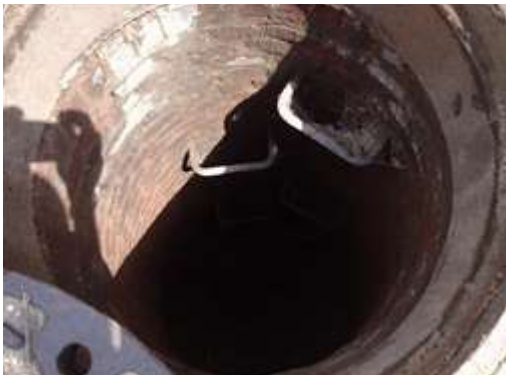
Defect 2

loose bricks

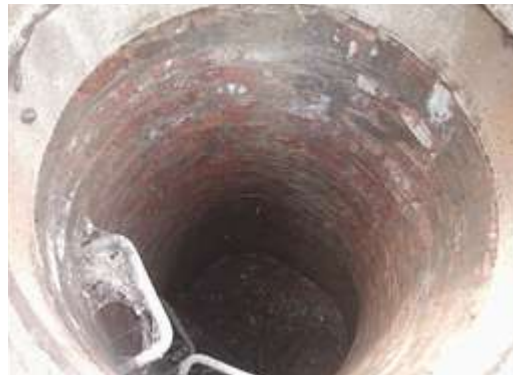
Defect 1

Infiltration: ☐ None ☒ **Joint** ☐ Cracks ☐ Mortar ☐ Roots ☒ **Wall**

infiltration

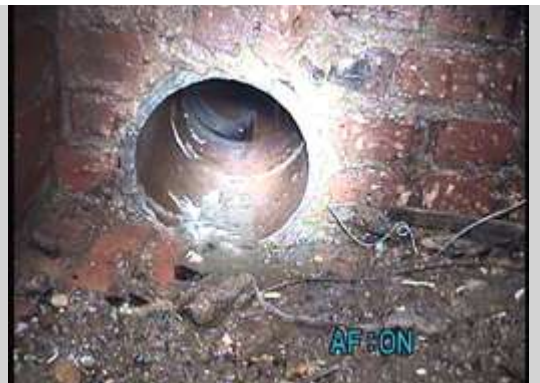
12 O'Clock Outflow

8 in. Circular Gravity Sewer
Pipe Out @ 12 O'Clock

Infiltration: **None** Pipe Seal Cond: **Sound**
